DEFECT LIST - CONTRACTOR ACTION LIST

# Harbour Point Construction Inspection

Harbour Road, Bristol

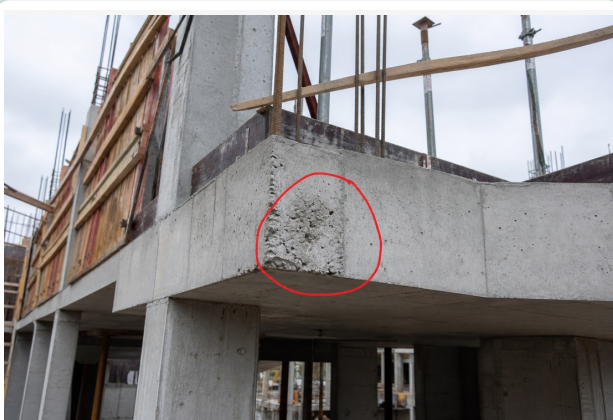
STR-002 Concrete honeycombing at beam corner

Structure Concrete Severity: Moderate Owner: Concrete subcontractor Due: Jul 12, 2026

Localized honeycombing at the exposed beam corner requires engineer review and an approved repair method.

Honeycombing marked at the exposed concrete corner.

Concrete subcontractor has this defect in progress. Reinspect by Jul 12, 2026 and attach after photos before sign-off.

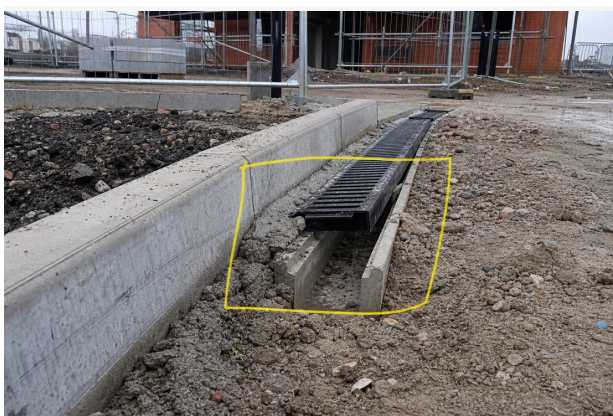
EXT-003 Channel drain cover not seated

External works   Drainage   Severity: Moderate   Owner: Groundworks contractor   Due: Jul 13, 2026

The channel drain cover is displaced and the surrounding haunching is incomplete.

Loose channel drain cover and uneven haunching marked on site.

Groundworks contractor to correct this defect by Jul 13, 2026 and provide completion evidence.

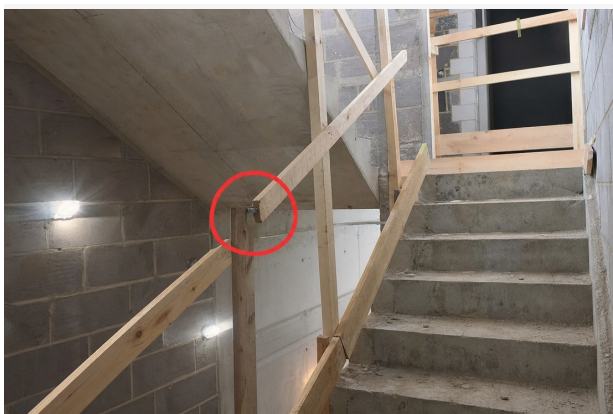
SAF-004 Temporary handrail fixing incomplete

Severity: Critical

The temporary stair handrail connection is incomplete and requires immediate correction before access continues.

Temporary handrail fixing marked during stair core walk.

Site manager to correct this defect by Jul 10, 2026 and provide completion evidence.

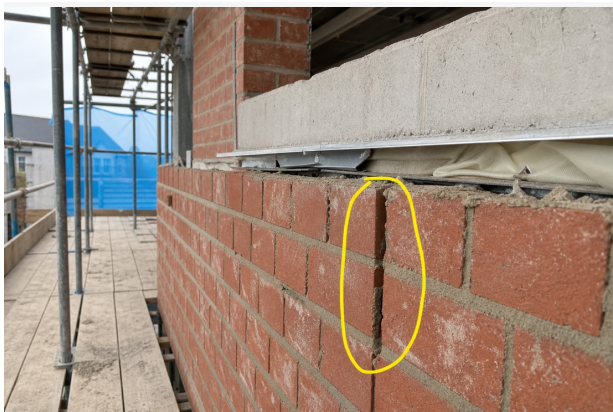
BRK-005 Open perp joint in brickwork

Facade Masonry Severity: Minor Owner: Brickwork contractor Due: Jul 14, 2026

The open vertical mortar joint at scaffold level requires repointing before the lift is struck.

Open perp joint marked on the scaffold lift.

Brickwork contractor to correct this defect by Jul 14, 2026 and provide completion evidence.
