DEFECT LIST

# Harbour Point Construction Inspection

Harbour Road, Bristol

| Westbridge Developments | SiteReportKit Demo | Northstar Site Reports |

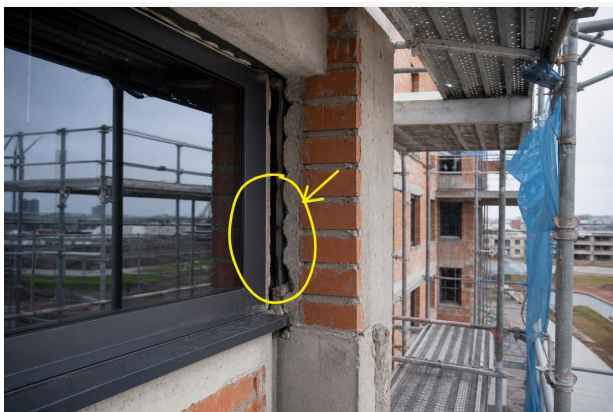
FAC-001 Window perimeter fire-stopping gap

Window perimeter fire-stopping gap

Visible gap at the window perimeter requires a compliant fire-stopping detail and documented closeout.

Window perimeter gap marked from the scaffold inspection.

Facade contractor to correct this defect by Jul 11, 2026 and provide completion evidence.

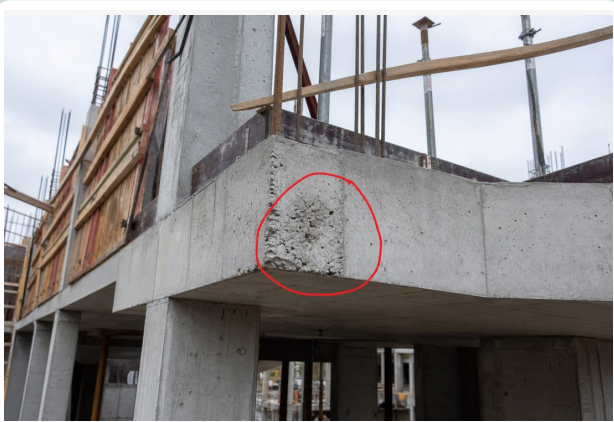
STR-002 Concrete honeycombing at beam corner

Localized honeycombing at the exposed beam corner requires engineer review and an approved repair method.

Honeycombing marked at the exposed concrete corner.

Concrete subcontractor has this defect in progress. Reinspect by Jul 12, 2026 and attach after photos before sign-off.

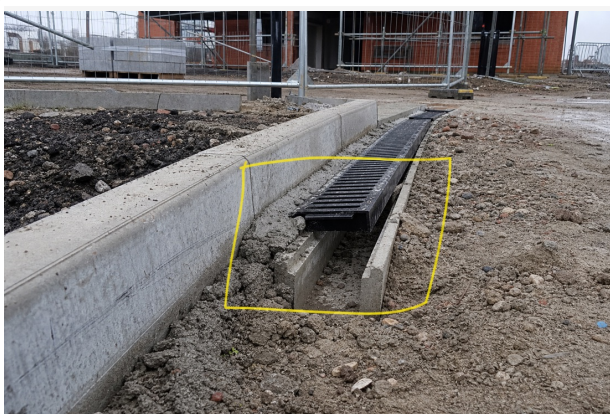
## EXT-003 Channel drain cover not seated

The channel drain cover is displaced and the surrounding haunching is incomplete.

**Loose channel drain cover and uneven haunching marked on site.**

Groundworks contractor to correct this defect by Jul 13, 2026 and provide completion evidence.

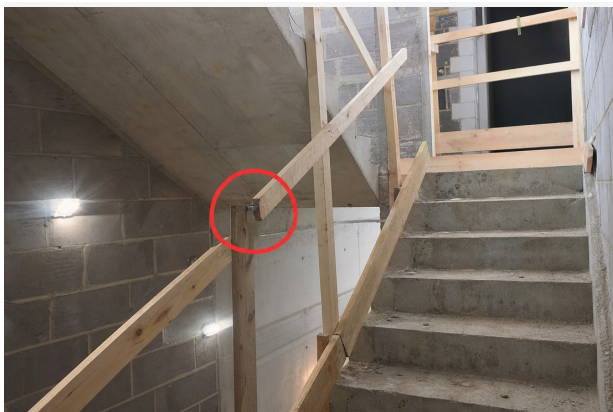
SAF-004 Temporary handrail fixing incomplete

The temporary stair handrail connection is incomplete and requires immediate correction before access continues.

Temporary handrail fixing marked during stair core walk.

Site manager to correct this defect by Jul 10, 2026 and provide completion evidence.

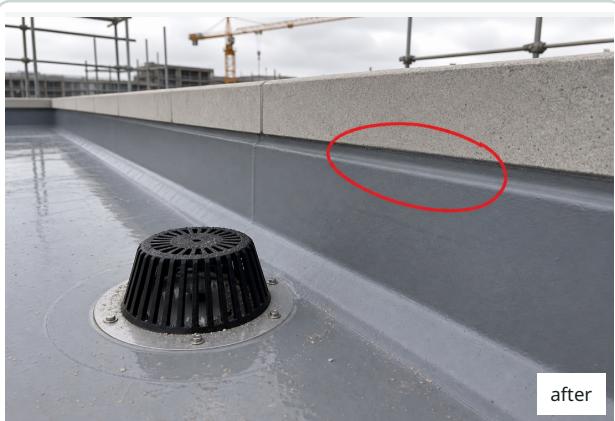
ROF-006 Roof drain membrane edge verified

The roof drain upstand and membrane edge were checked after remedial sealing.

Roof drain membrane edge marked after remedial seal.

Sealant edge and drain surround were accepted at closeout.
