## SNAGGING REPORT

# Maple Row Handover

18 Maple Row, Bristol

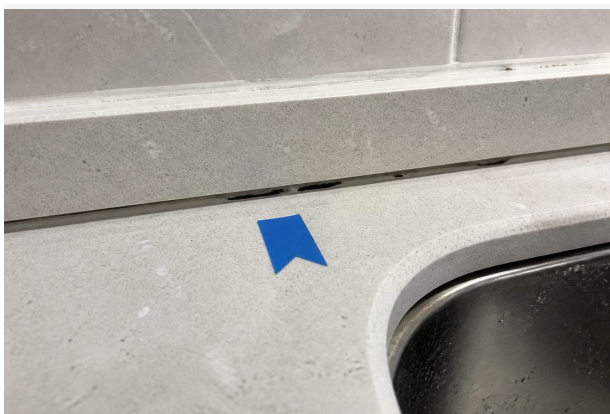
Jul 7, 2026 - kitchen-sink-upstand.jpg

Severity: Moderate

Visible gap behind the sink upstand. Sealant should be completed before handover sign-off.

**Gap visible behind sink upstand before sealant.**

Developer to correct this snag by Jul 14, 2026 and provide completion evidence.

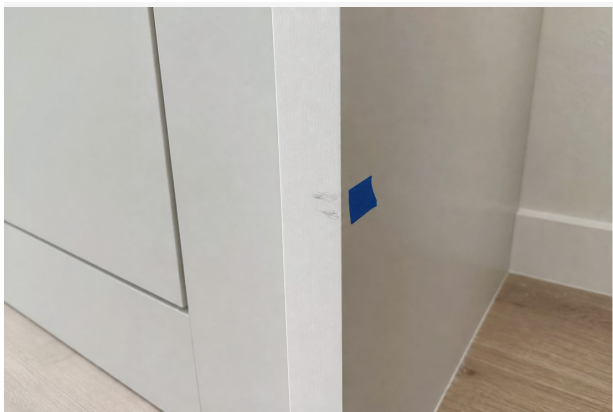
Jul 7, 2026 - wardrobe-return-scuff.jpg

Touch up required on the left wardrobe return. Surface is otherwise sound.

Paint scuff visible on the wardrobe return.

Painter has this snag in progress. Reinspect by Jul 6, 2026 and attach after photos before sign-off.

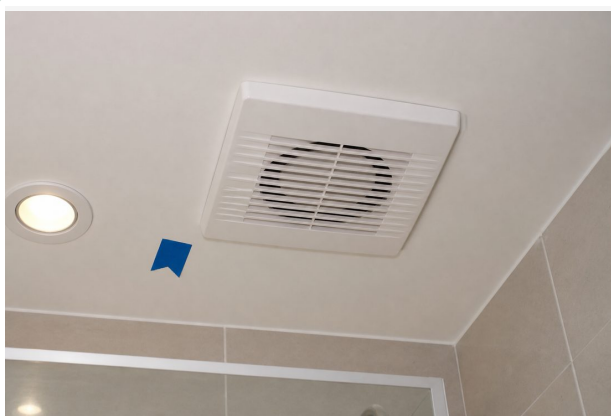
Jul 7, 2026 - bathroom-extractor-fan.jpg

Severity: Critical

Fan does not start when the light circuit is activated. Confirm power and replace if needed.

**Extractor fan did not operate during the check.**

Electrical subcontractor to correct this snag by Jul 9, 2026 and provide completion evidence.

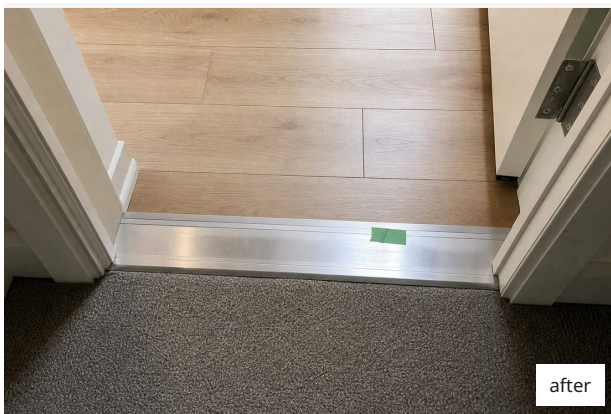
Jul 7, 2026 - front-door-threshold-after.jpg

Threshold scratches were polished and verified during reinspection.

Threshold polished and accepted at reinspection.

Polished on site and accepted during the follow-up walk.
